Manhole Inspection Summary

Manhole # S69M__003MH

Location Address: **6525 O'Donnell St.**

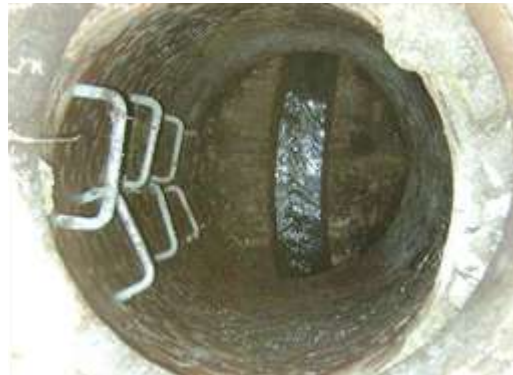
Top View

Frame Offset: **3** (in.) Condition: ☐ Sound ☒ **Cracked** ☒ **Leaks**

Condition: ☐ Sound ☐ Cracked ☐ Root Intrusion ☒ **Loose Brick** ☒ **Deteriorated**

Infiltration: ☐ None ☒ **Joint** ☐ Cracks ☒ **Mortar** ☐ Roots ☐ Wall
